Naval Safety Center Publication

MARCH 1971 THE NAVAL AVIATION SAFETY REVIEW

a review
of aircraft accidents
due to

FUEL

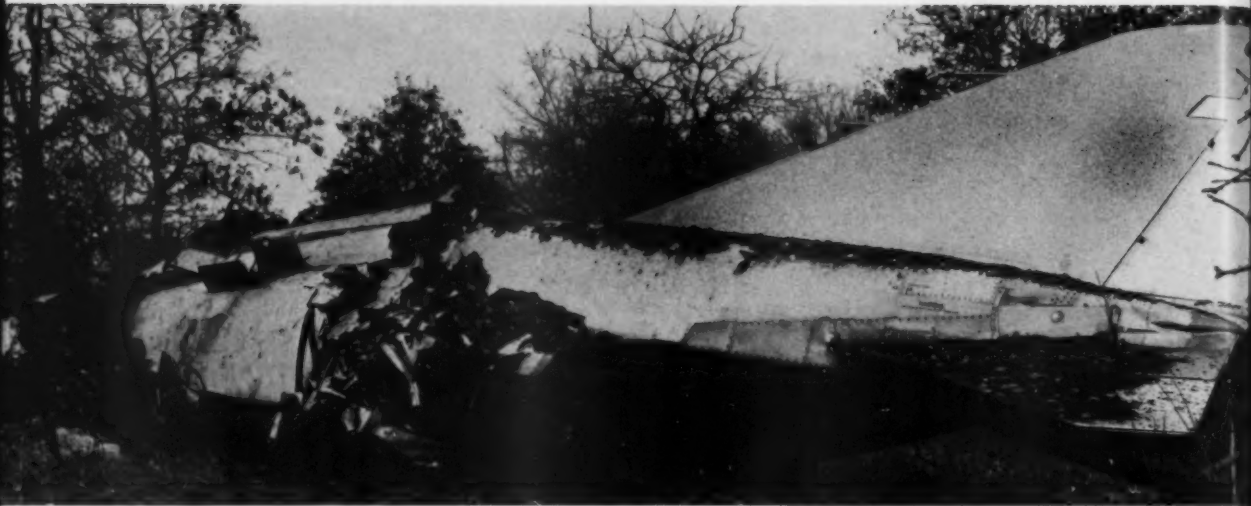
Fuel exhaustion occurred 1.5 miles short of destination.

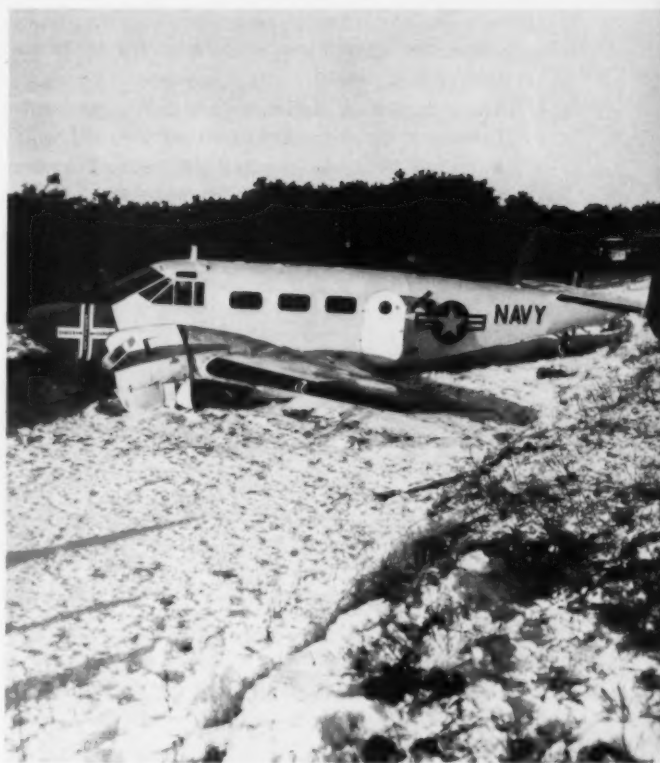
The fuel selector was improperly positioned.

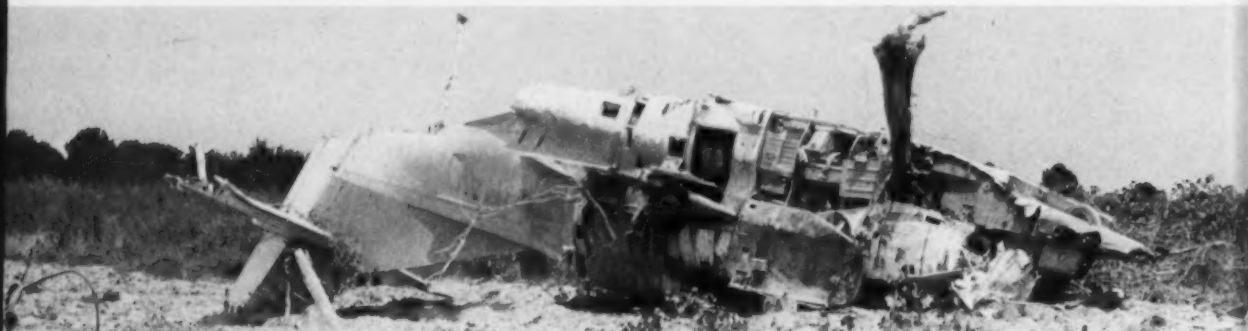
It is suspected that student erroneously operated landing light switch instead of fuel transfer switch.
